## Robinson Helicopter Company Accident Report

AIRCRAFT MODEL:	<u>R44 Clipper I</u>
SERIAL NUMBER:	<u>1295</u>
REGISTRATION:	<u>N7530R</u>
ACCIDENT DATE:	<u>30 January 2018</u>
ACCIDENT LOCATION:	<u>Newport Beach, California</u>
NTSB IDENTIFICATION:	<u>WPR18FA077</u>

REPORT WRITTEN BY: Ken Martin

DATE: 17 June 2019

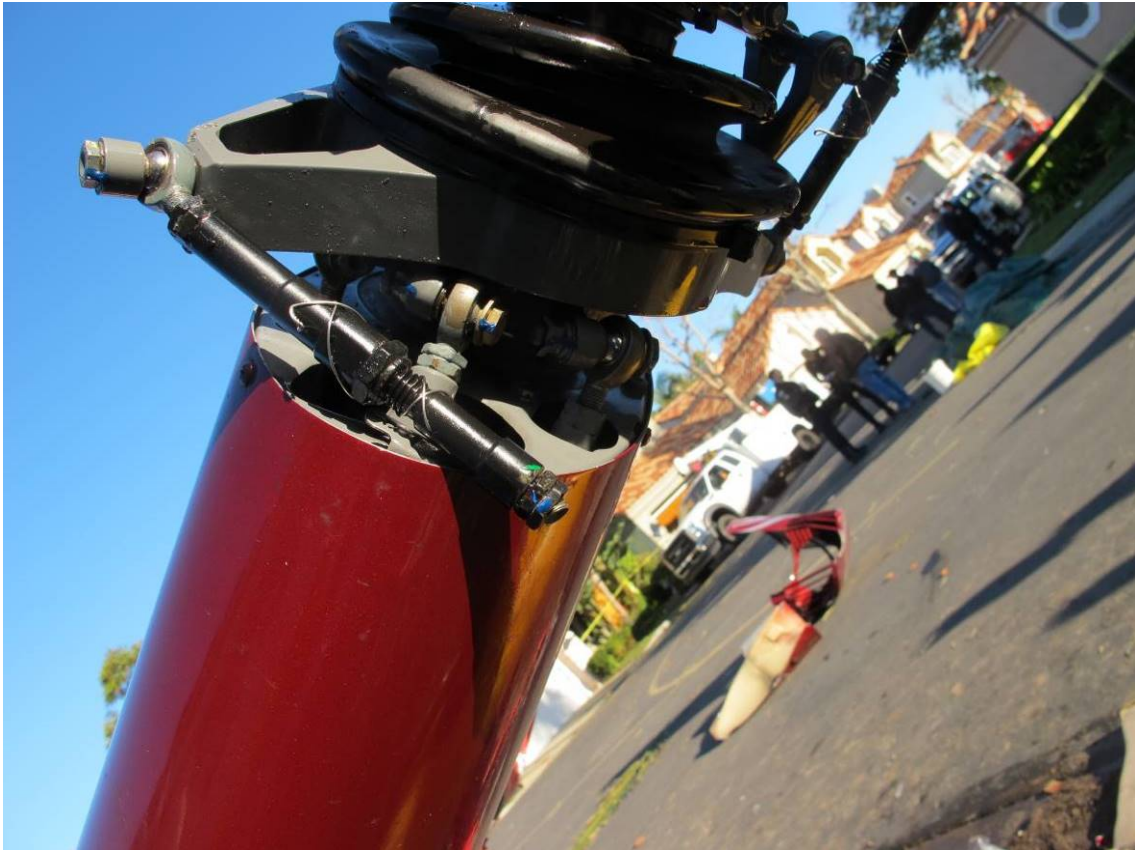
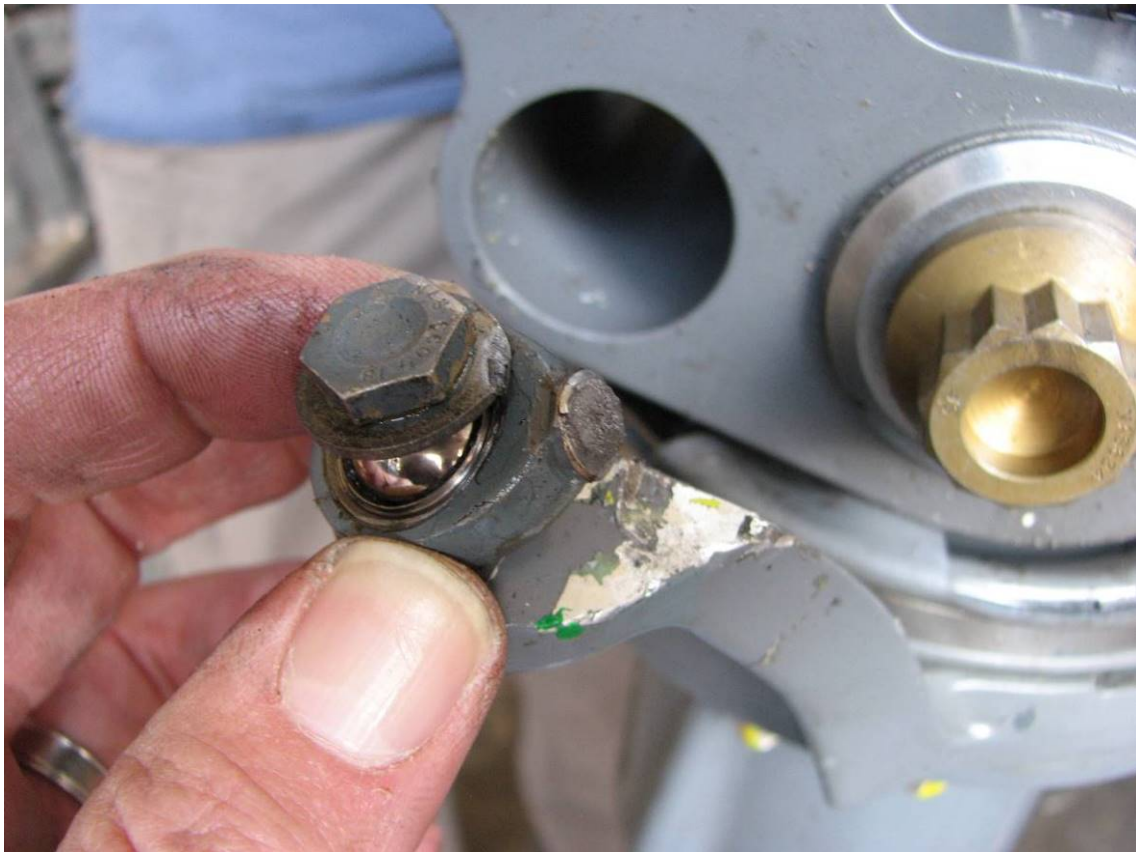
Disconnect A in the pitch link for main rotor blade SN 7862

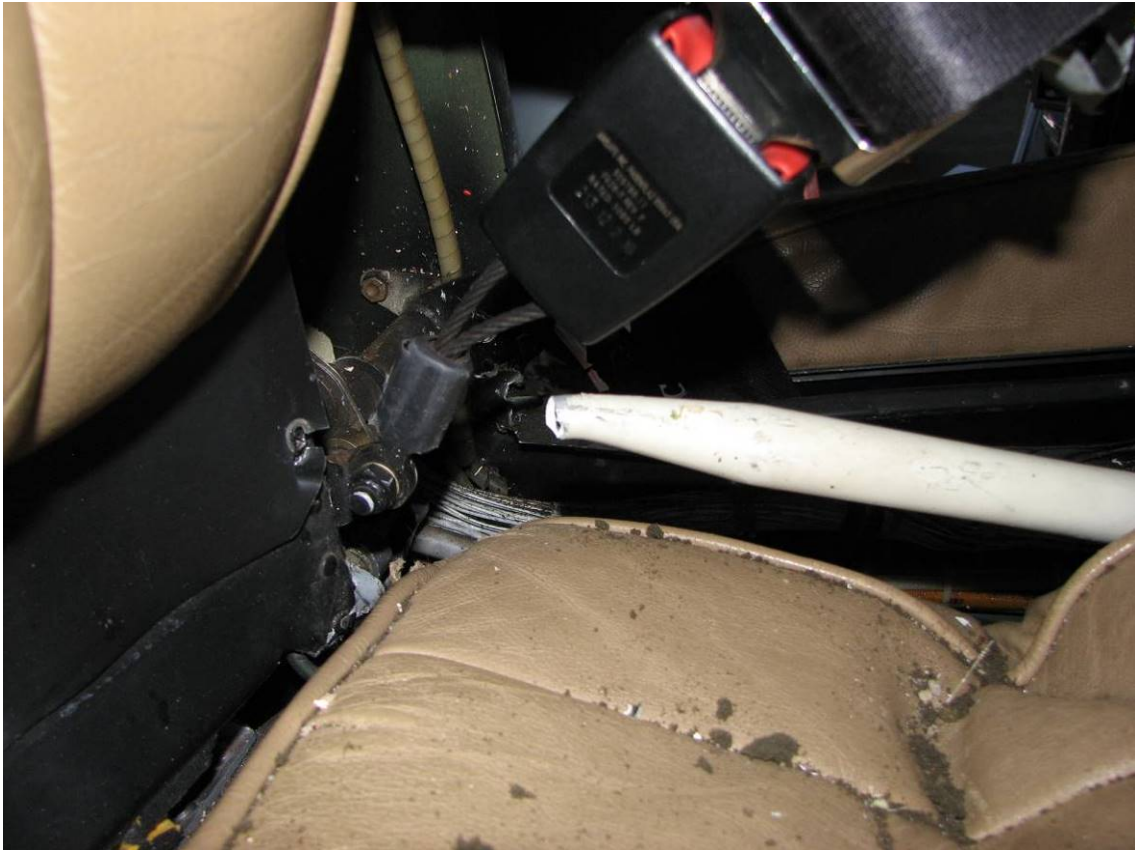
Disconnect B at the aft end of the C121-19 push pull tube

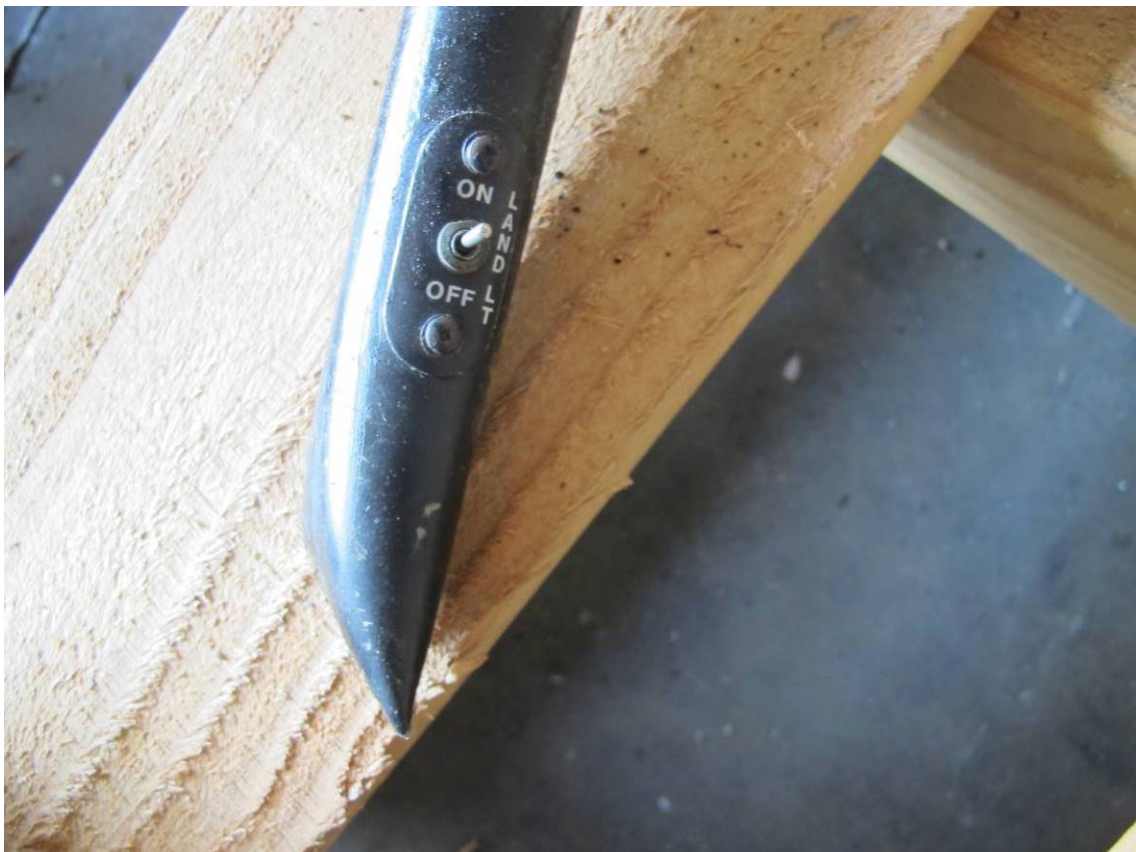
Disconnect C in the cyclic stick (cut by emergency responders)

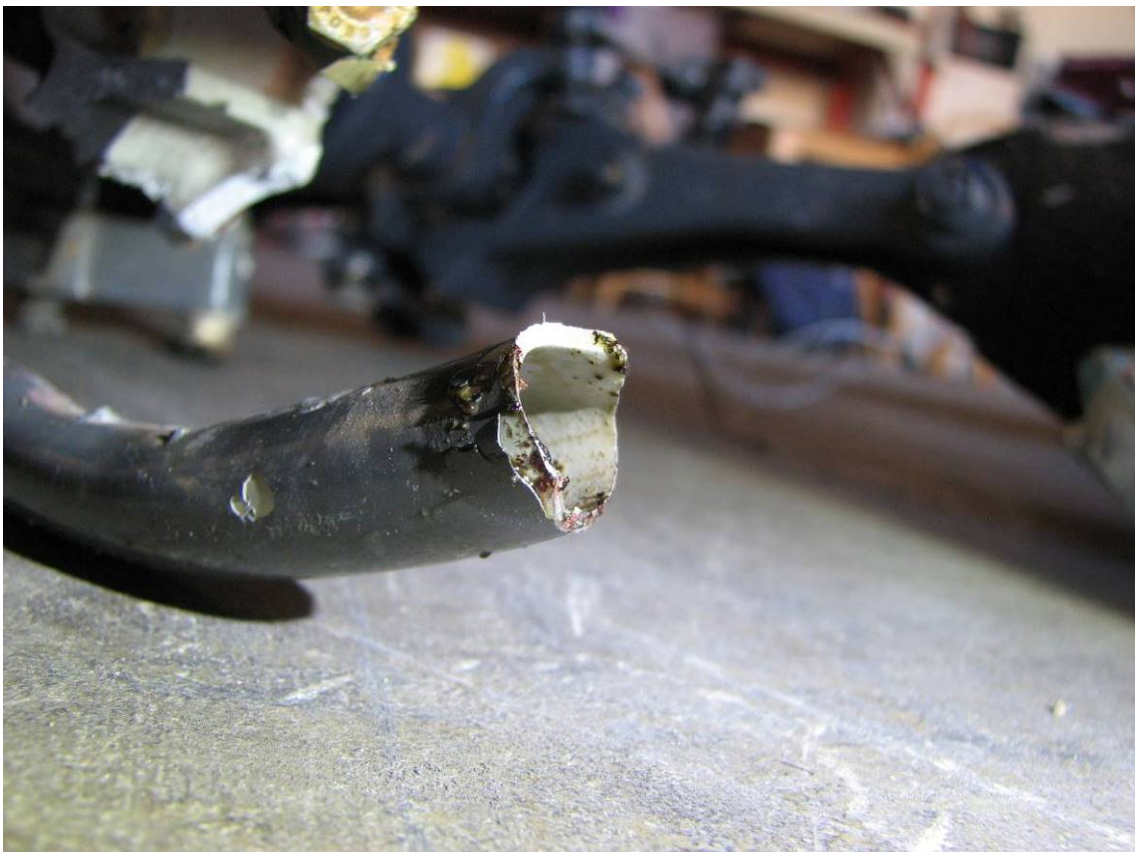
Disconnect TA in the C121-17 push pull tube

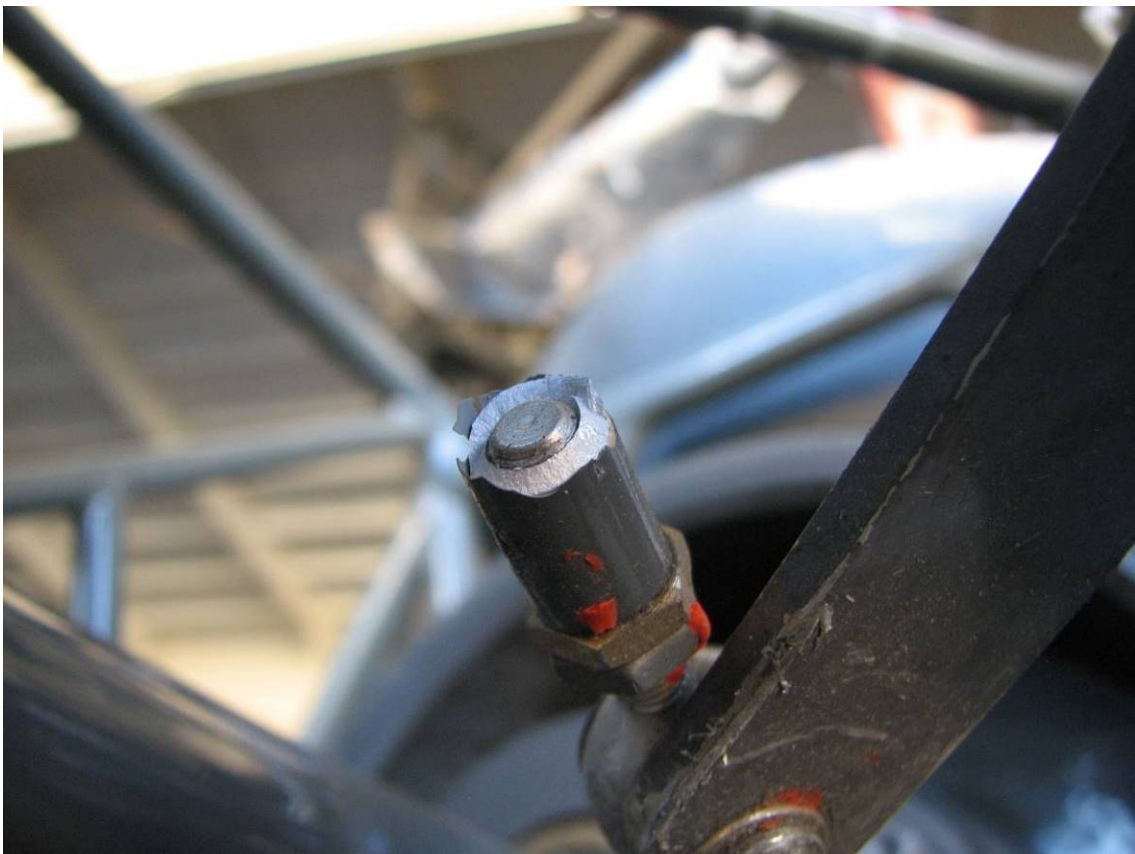
Disconnect TB in the C121-17 push pull tube and the A331-4 tail rotor bellcrank

Disconnect TB in the C121-17 push pull tube

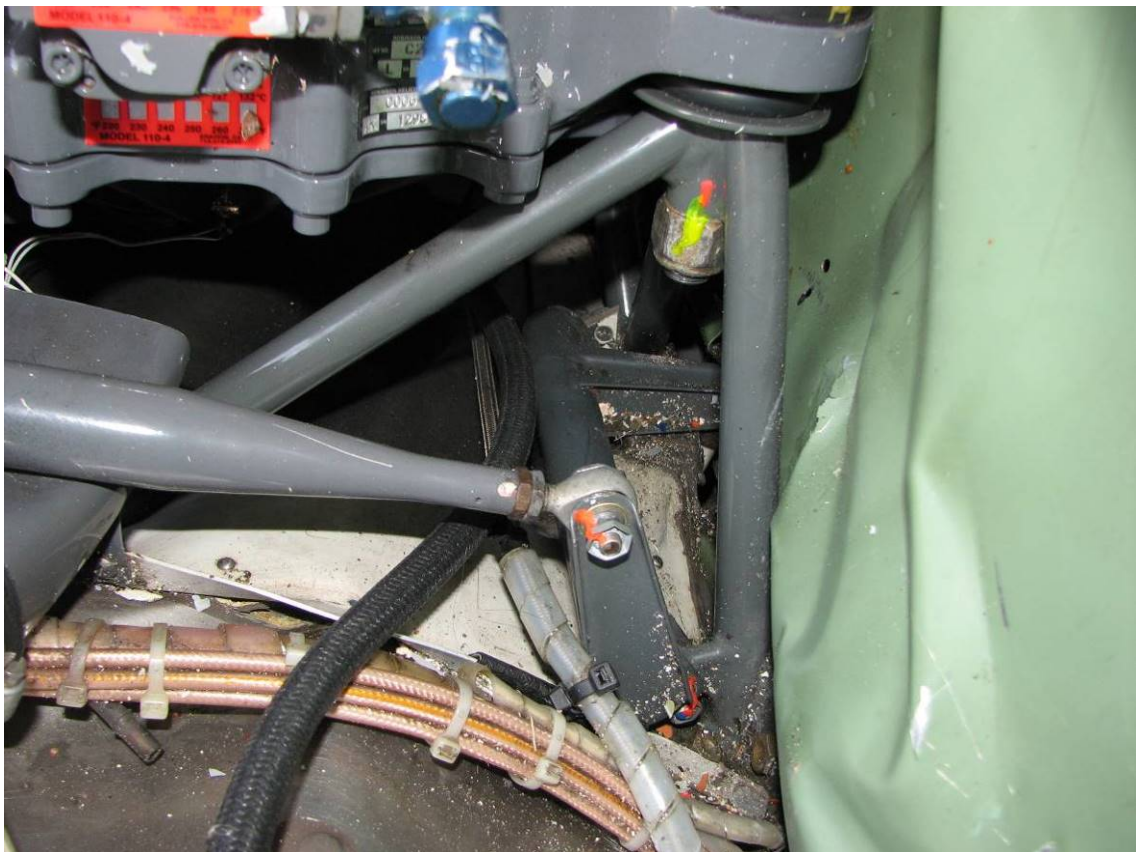
The C316-1 bellcrank at the firewall intersection

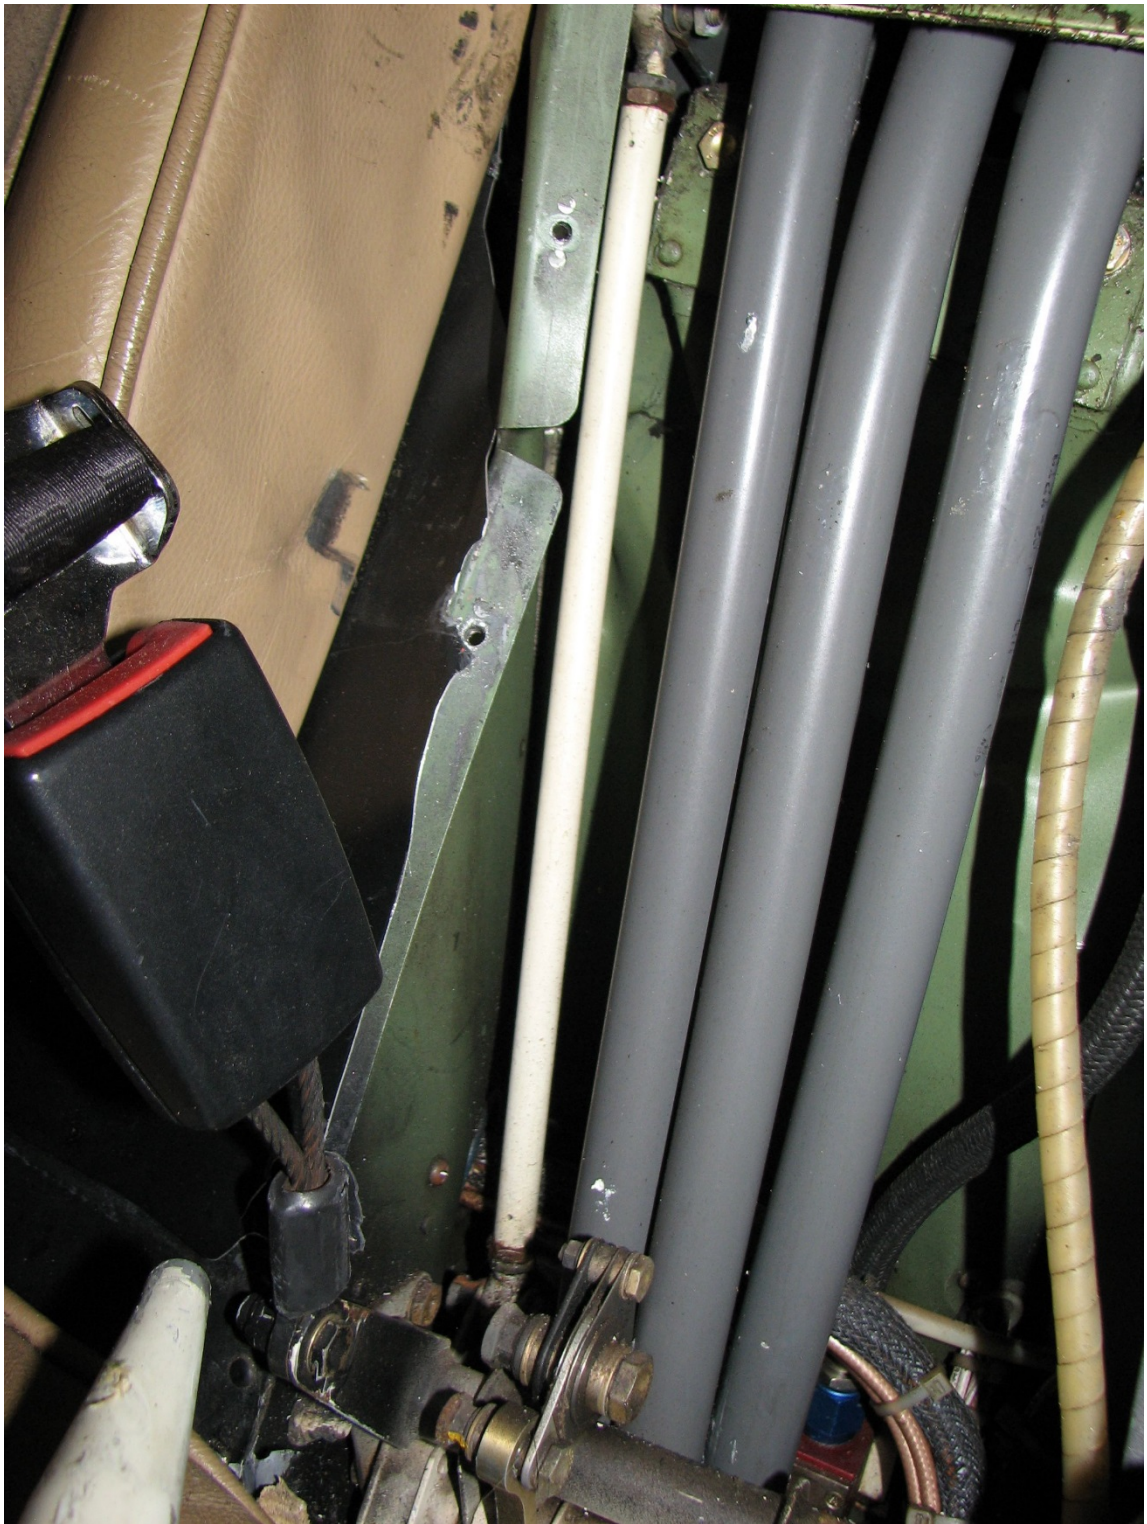
The C343-1 push pull tube

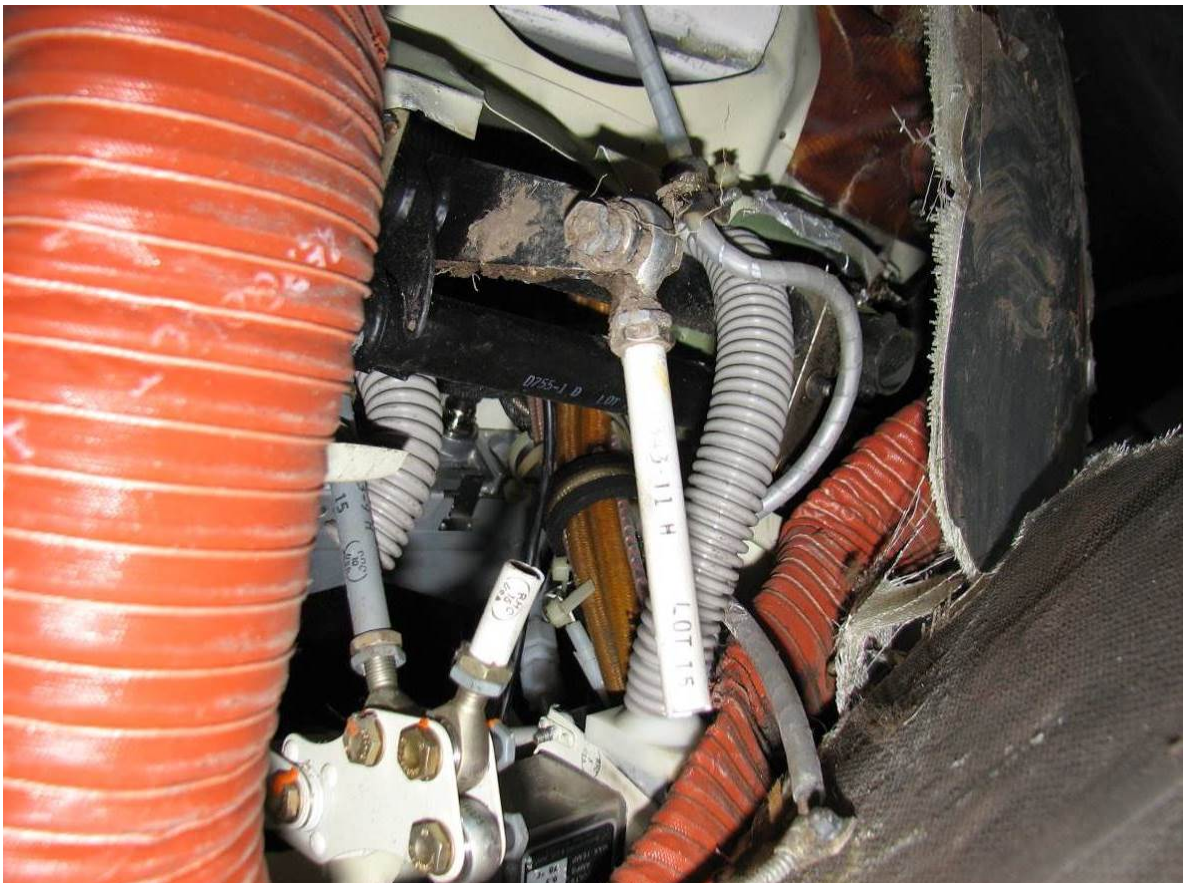
The tail rotor control tubes at the pedals

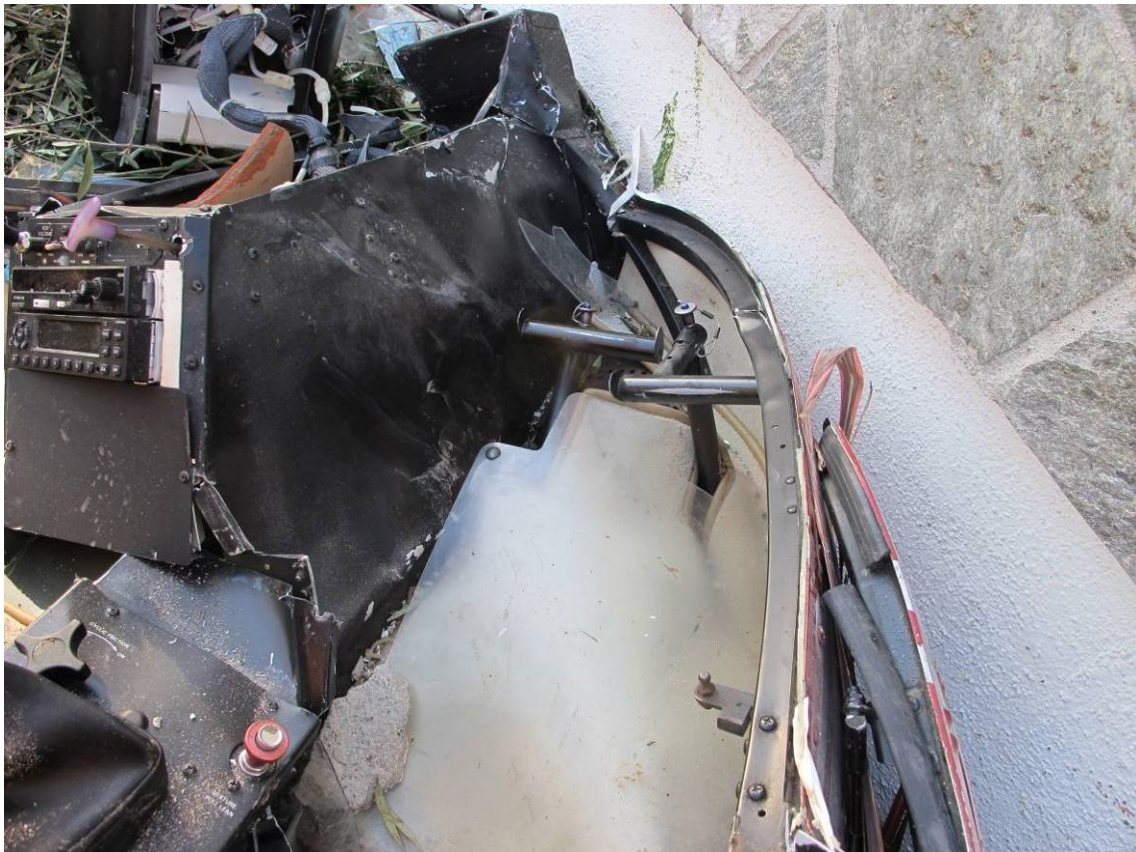
The tail rotor pedals, pilot side

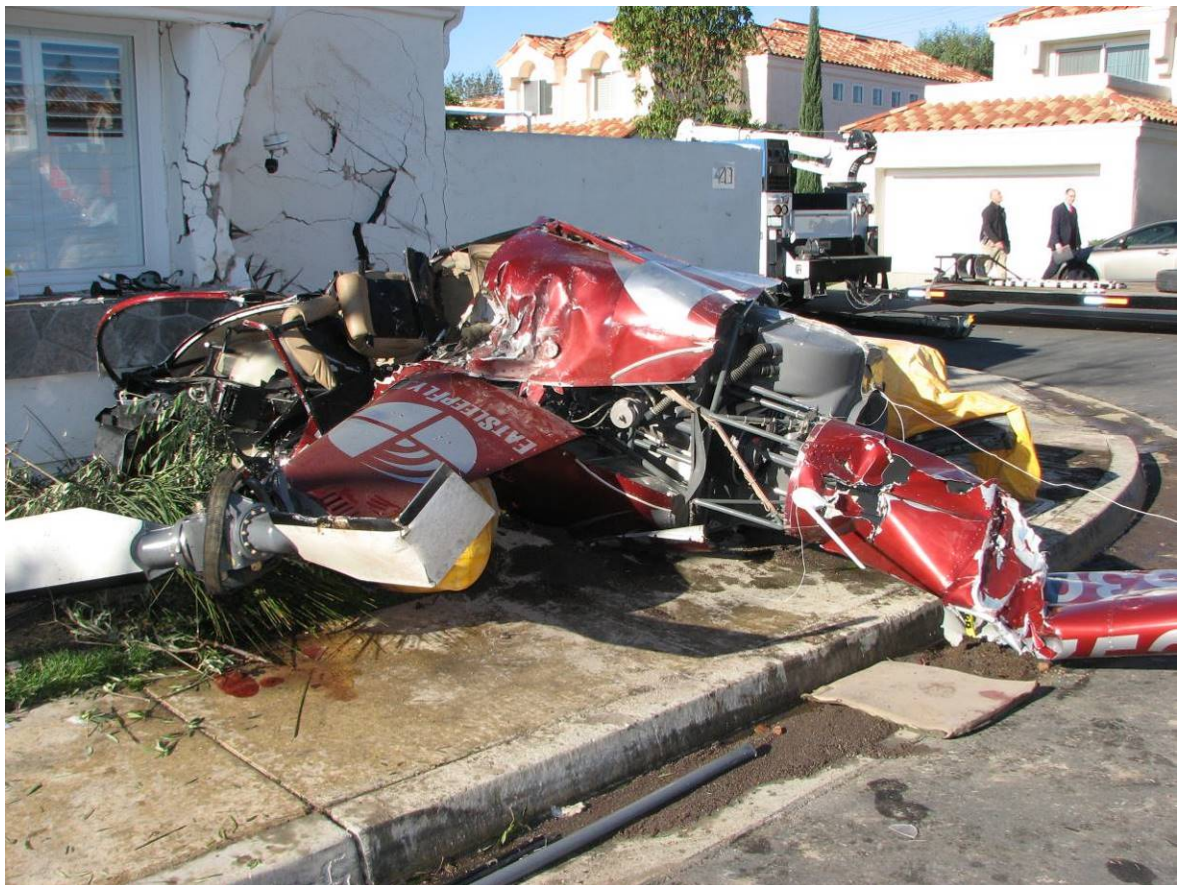
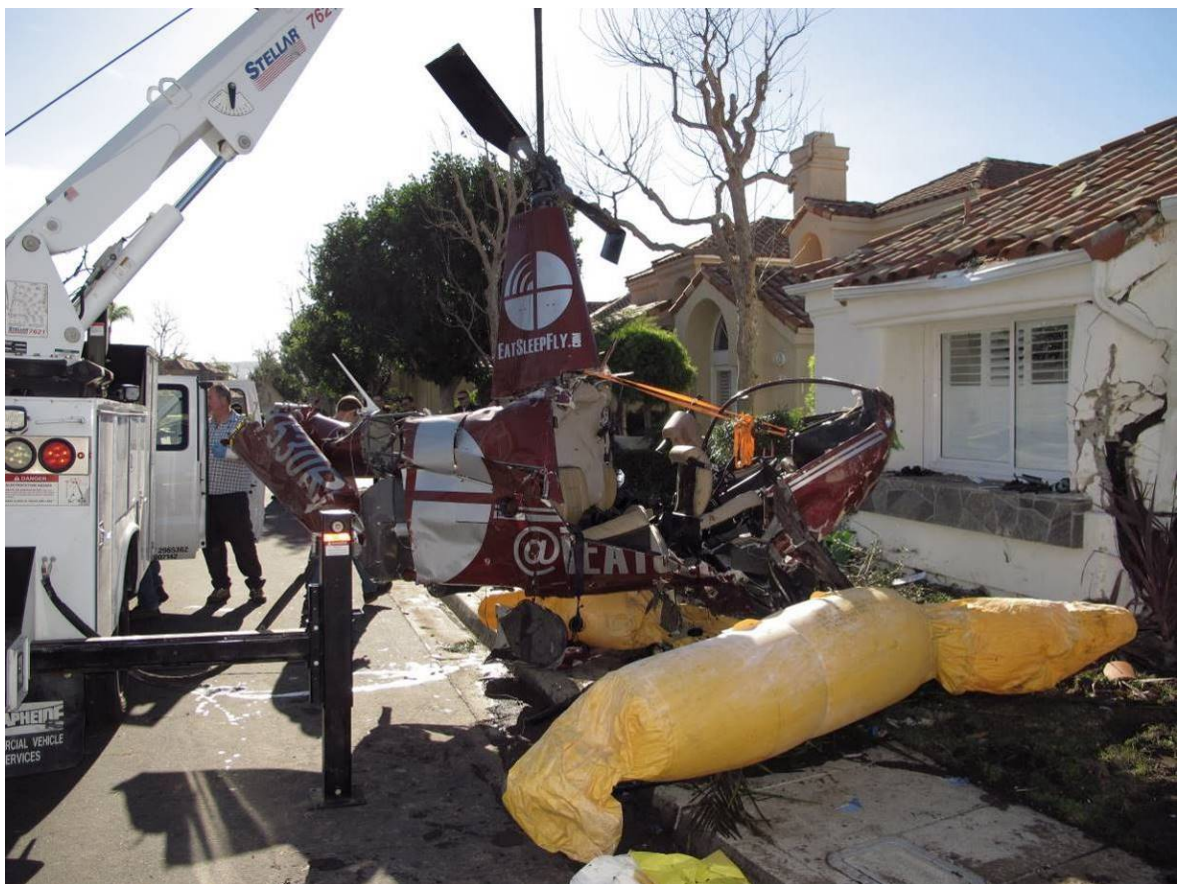
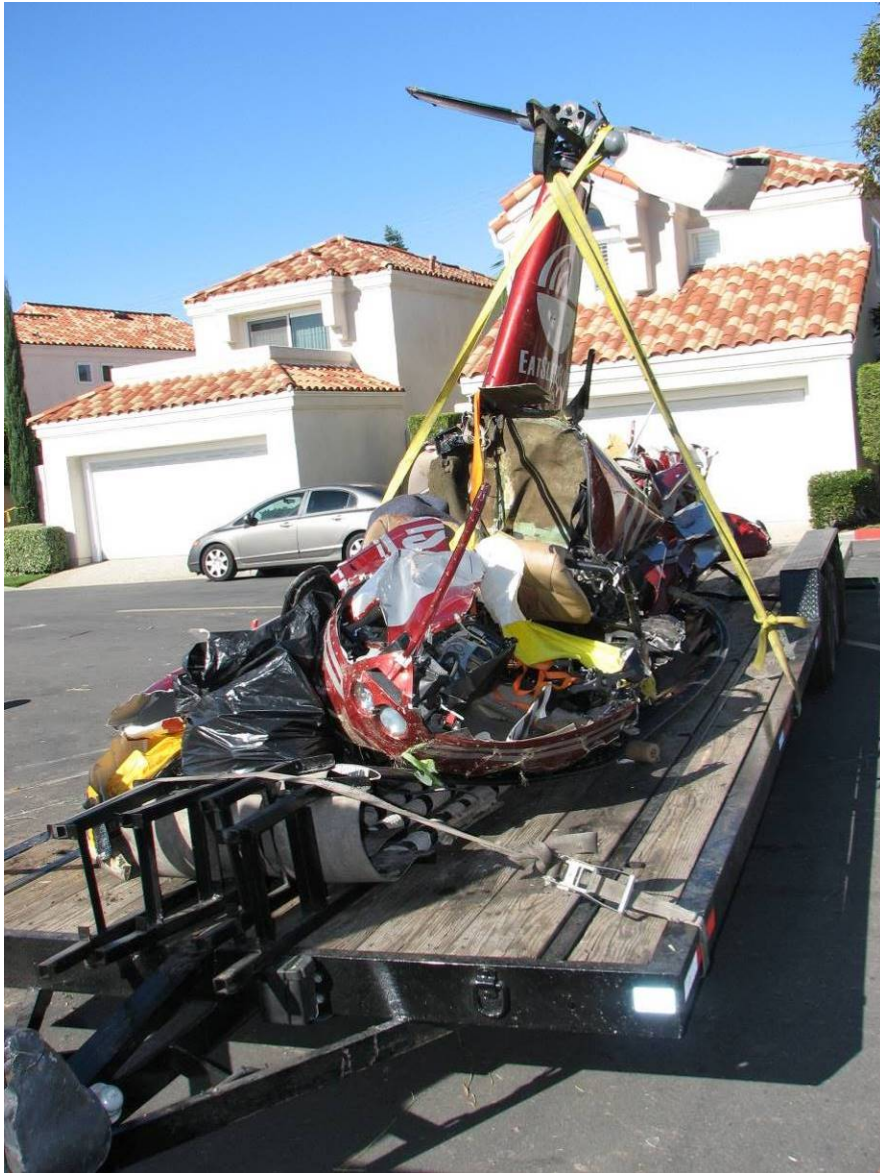
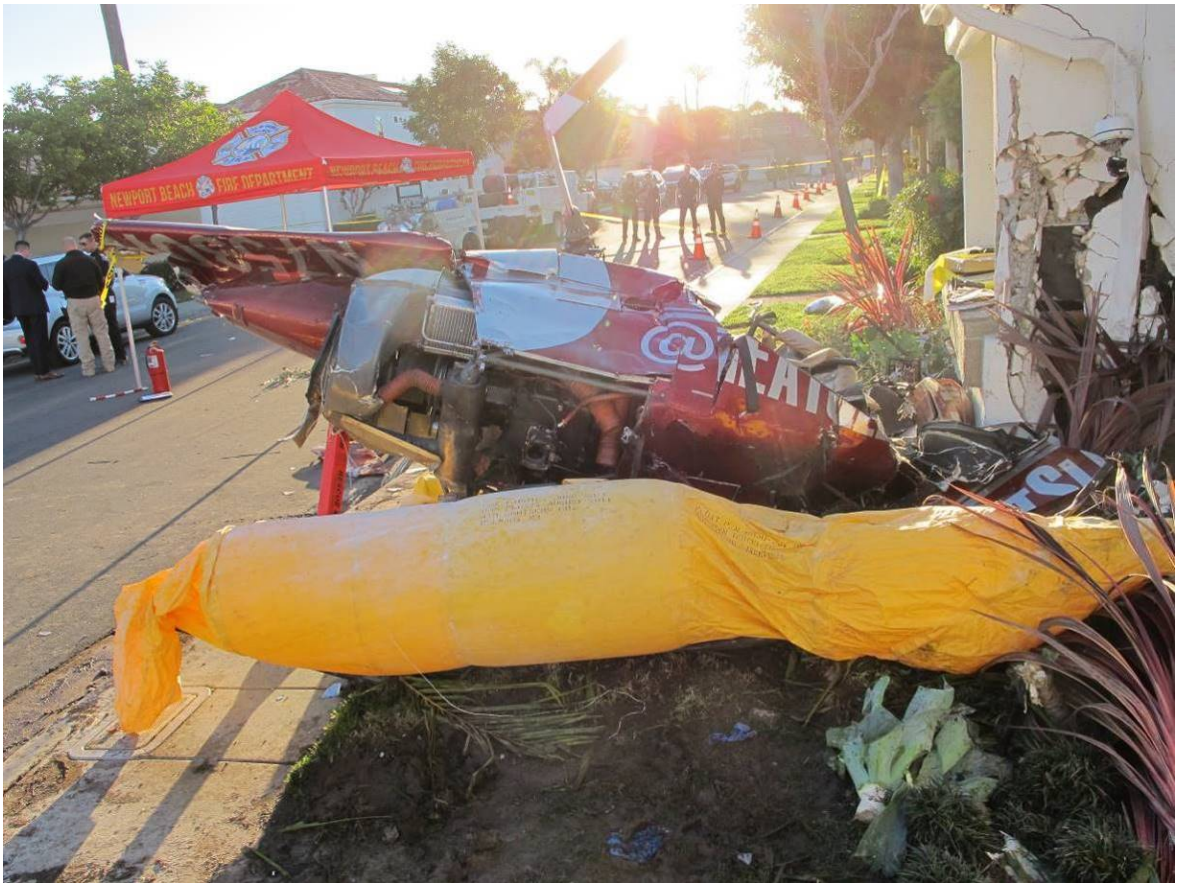
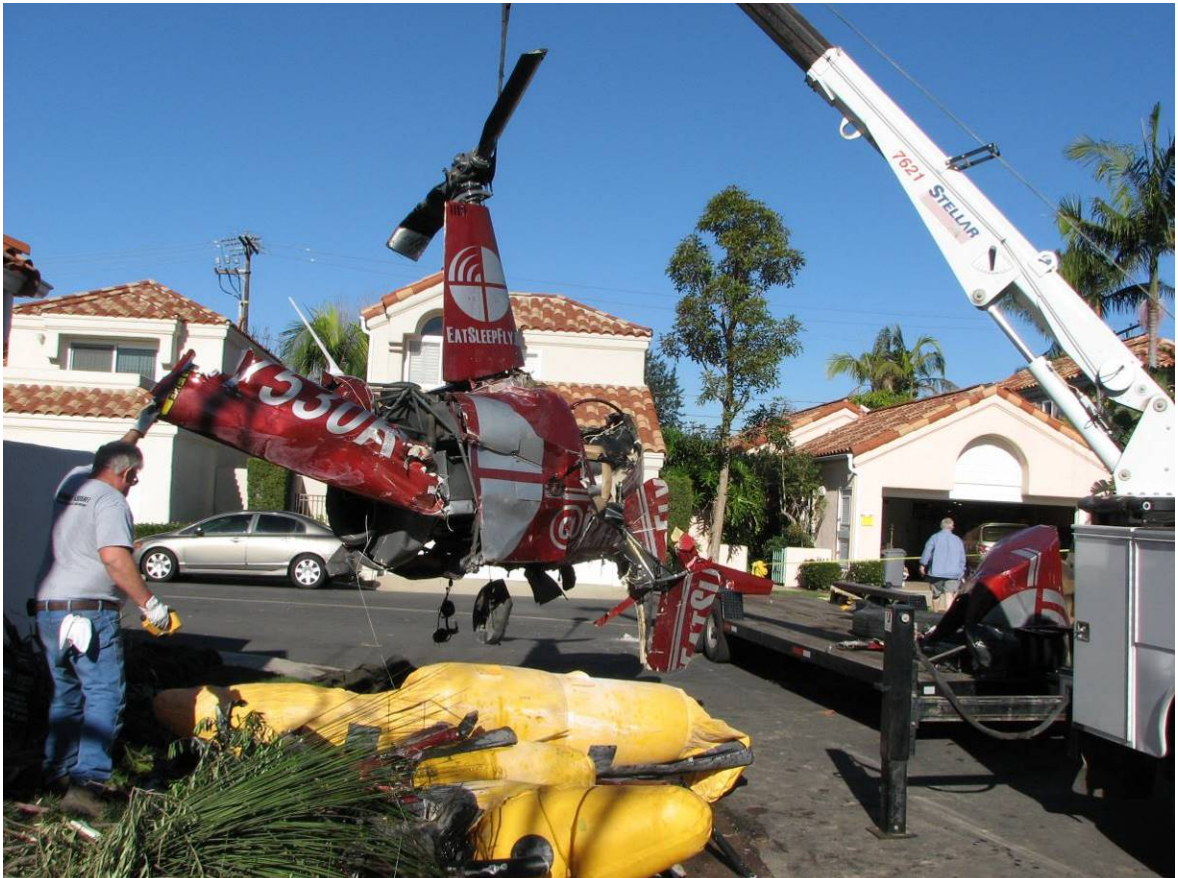
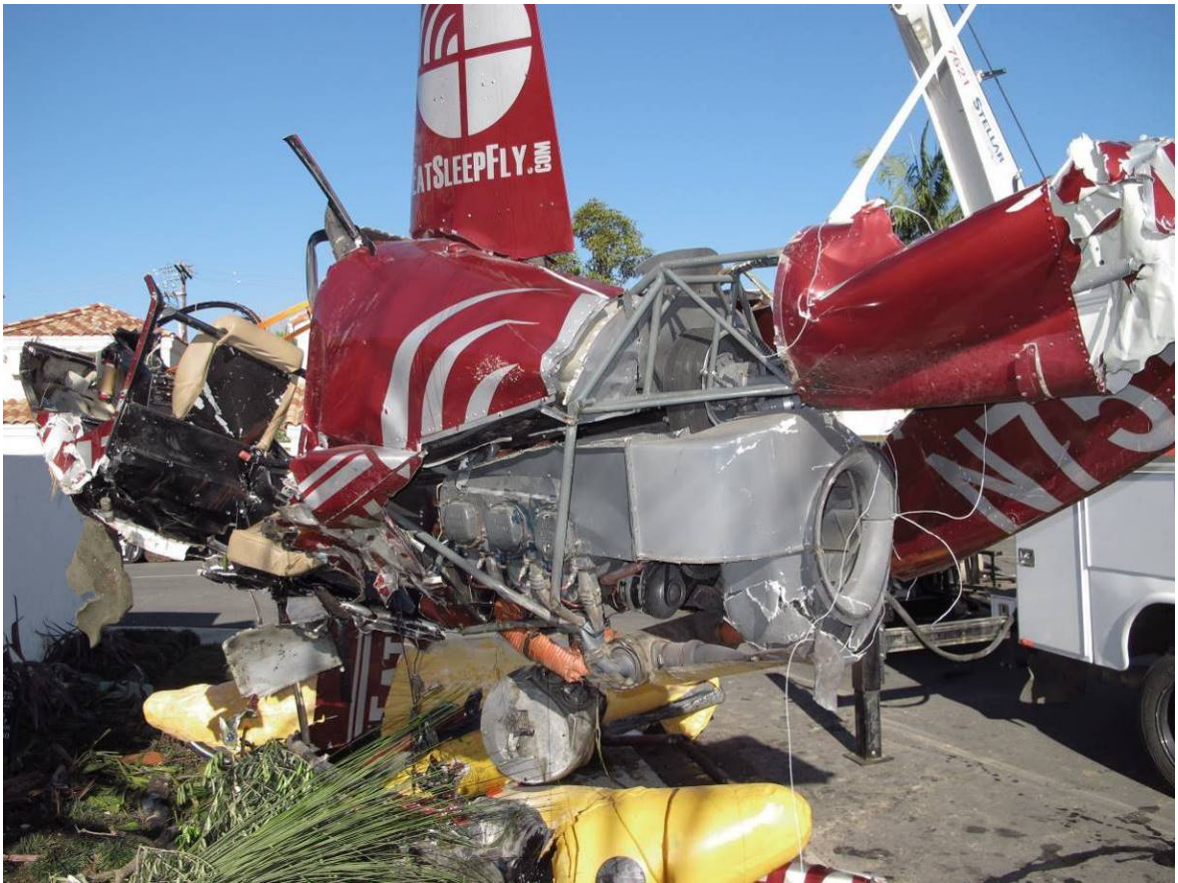
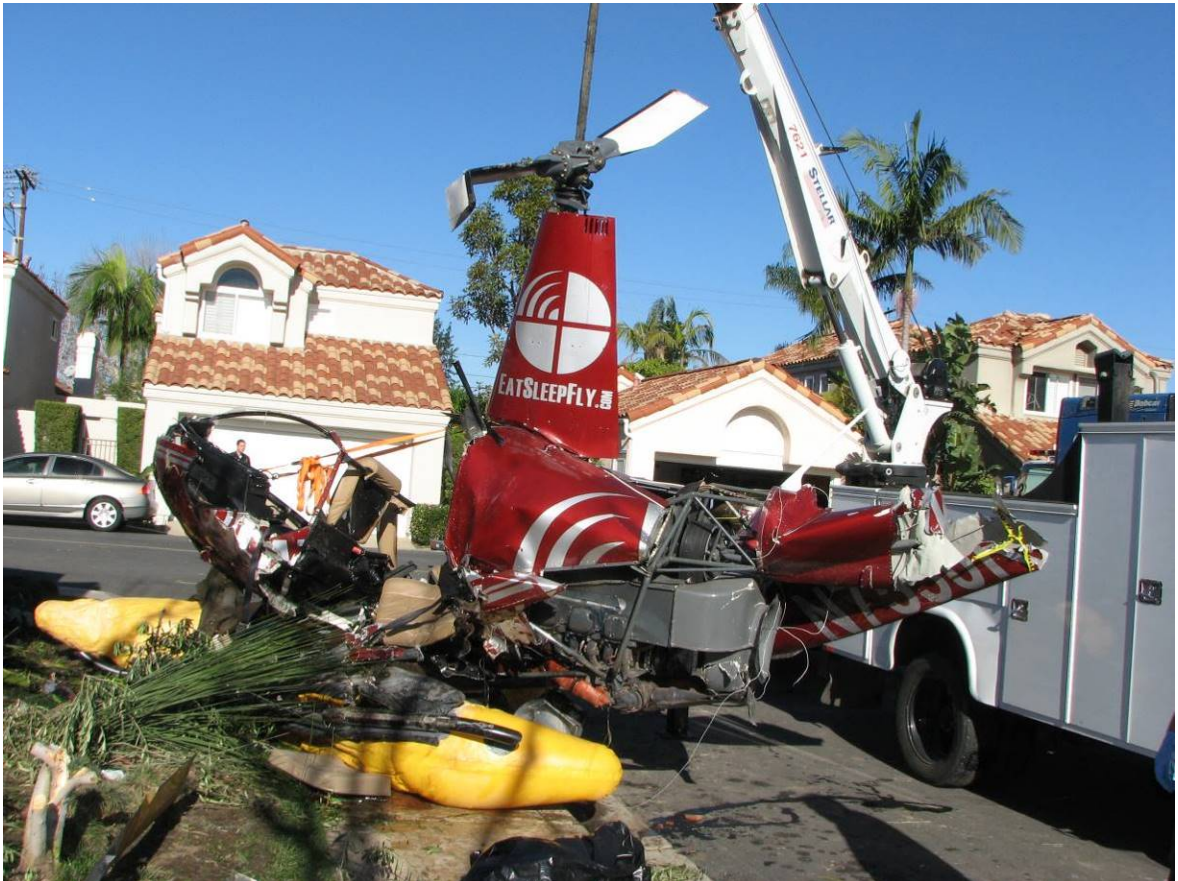
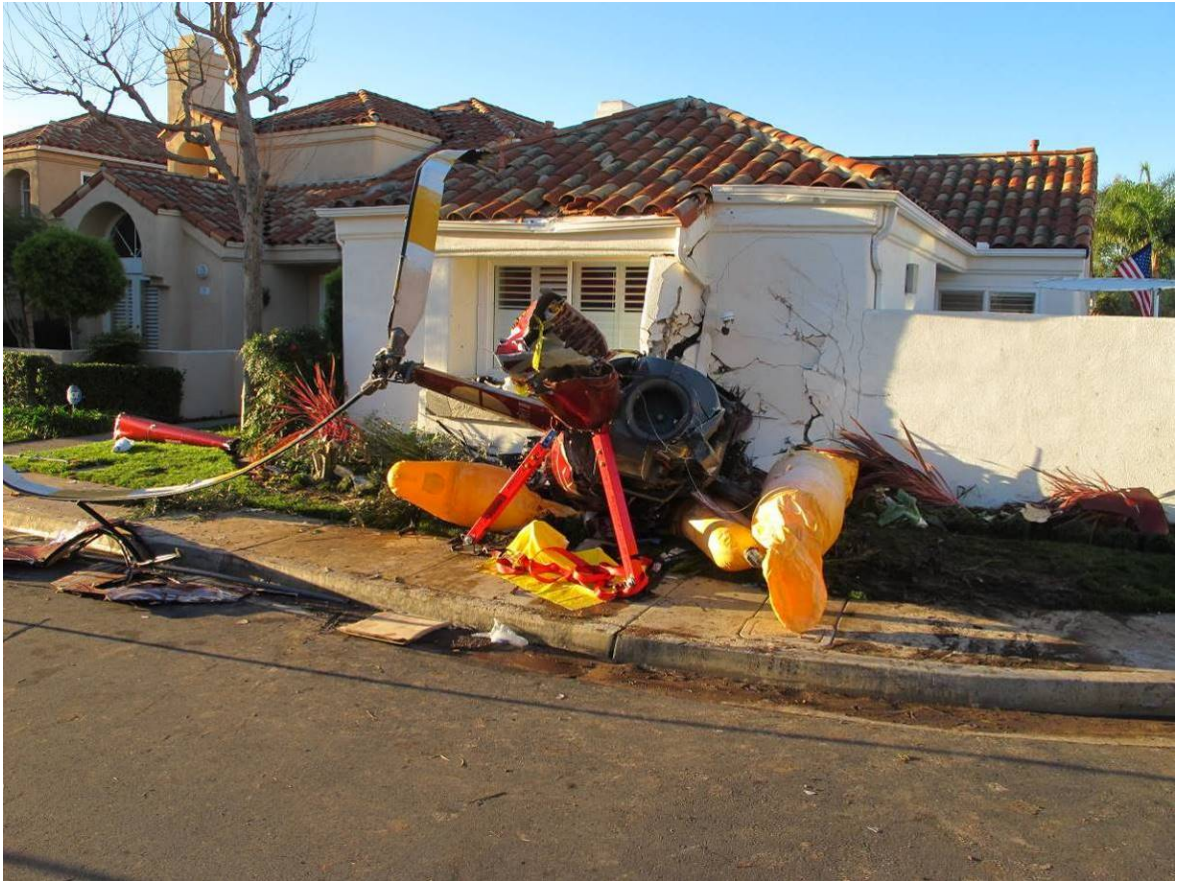
The airframe sustained substantial impact damage.

The cabin structure was deformed and fractured. The roof and door frames were cut by first responders. Fragments of both windshields and all four doors were recovered near the main wreckage.

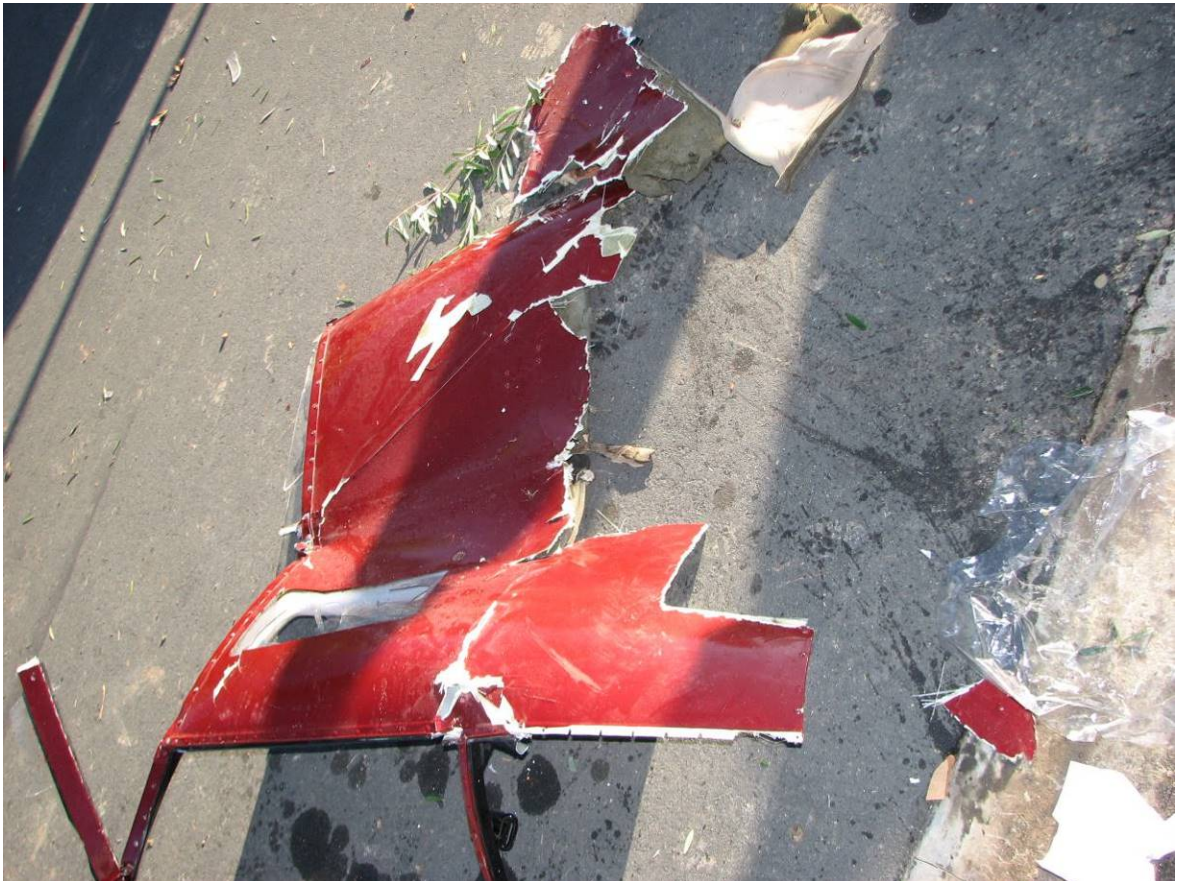
The cabin roof

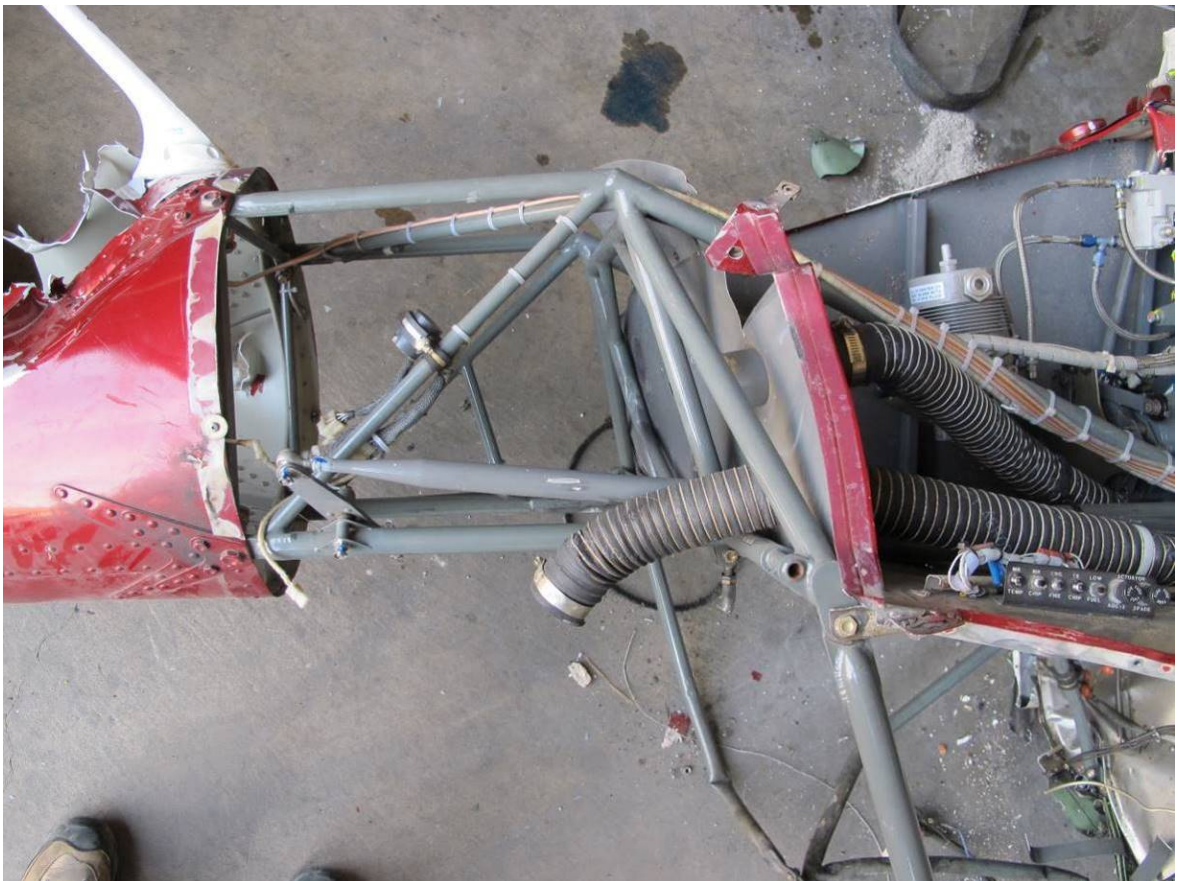
The upper steel tube frame had no visible damage. Both lower steel tube frames were bent near the landing gear mounts.

The steel tube frame at the tailcone attachment
